# RECTIFICATION OF LEAKED CONCRETE OVERHEAD TANKS USING (WATER GUARD 491)

## Summary

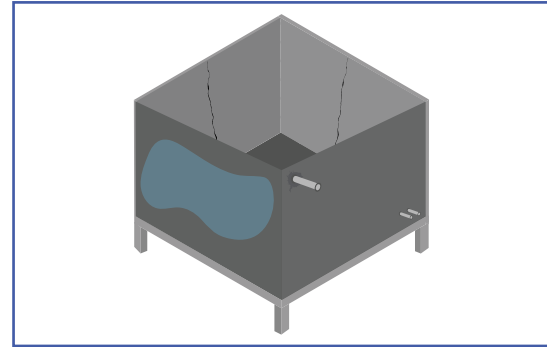
### Step 1: Assessment of overhead tanks

It is essential to have a proper survey & diagnose the area where the water tank is being leaked & then move towards the rectification of the tank. The survey should be done both externally & internally within the overhead tank. It is to be ensured that the overhead tank is dry prior to the internal inspection so that any areas of the leakage can be identified easily.

During the inspection cracks within the overhead tank, leakage from the pipe inlets and outlets, and the condition of the chamfers along with the condition of the internal plaster need to be diagnosed thoroughly. Once the diagnosis of the problems has been done, working towards the rectifications of these problems can be done.

**STEP 1:** Assessment of Over Head tanks.

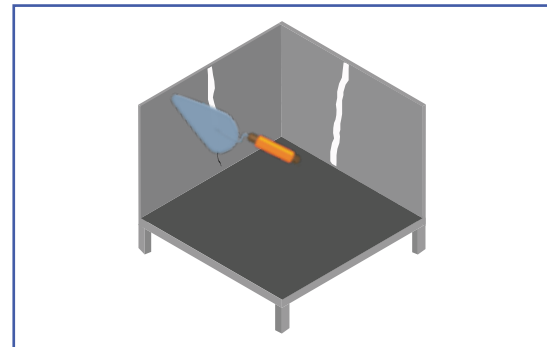
### Step 2: Crack Filling & making of internal chamfers (If Needed)

Upon inspection if cracks are found over the plastered surface of the internal or external surface of the overhead tank, they should be further inspected for plaster hollow sounds, if the plaster has been de-bonded and there are hollow sounds, there will be a need for replastering. If there are no hollow sounds and the plaster is in a solid state, there may be a simple need for crack filling.

There is a wide range of Crack Fillers in the **Crack Heal** Range of Ressichem crack fillers. In general, if there are minor hair line cracks, **Crack Heal 920 2K** should be used, if the cracks are wide & need a deeper filling, **Ressi EPO Crack Fill** can also be used depending on the situation. For further guidance for the right selection of crack fillers please consult Ressichem representative.

**STEP 2:** Crack filling and making of internal chamfers. (If needed).

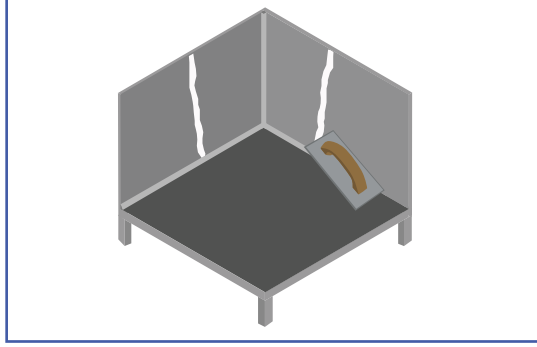
If there are running cracks on both sides of the overhead tank and the structure of the retaining walls and base have been detached, please consult a structural engineer prior to any treatment over the overhead tank. For further information on the suggested products, please also refer to the product Technical Datasheet for application guidance.

**Water Guard Crysta Coat 101** can be mixed to the dry mortar consistency and used to fill the cracks. If there is any active water leakage, then **Water Guard Crysta Coat 101** can be mixed with a suitable plugging material recommended by Ressichem at a Ratio of 1:1 and fixed at the point of water leakage to stop the flow of water. Over such treatment two coats of **Water Guard Crysta Coat 101** can be applied at a said rate of application.

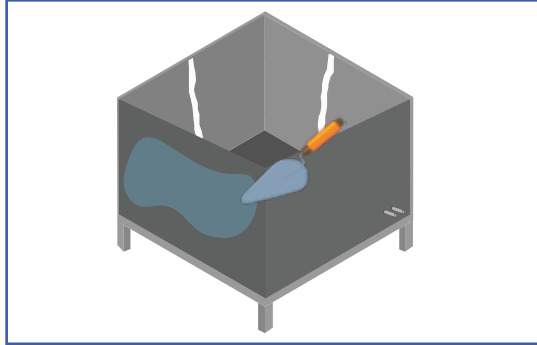
## Step 3: Plugging internal pipe points. (If needed)

If on inspection it is found that the pipe inlets & outlets of the tanks have been leaking it is essential to plug those points of the pipes. Points of the pipes. A suitable crystalline plugging material can be used for this application. **Water Guard Crysta Coat 101** is a crystalline waterproofing material which can also be used as a plugging material for the pipe inlets and outlets of the tank. The pipe points of the pipes. A suitable crystalline plugging material can be used for this application. points through which the leakage is taking place can be cut open at 8mm and the **Water Guard Crysta Coat 101** mortar can be used to plug the points and seal them off. Once the points have been sealed, the points should be kept moist by damp curing for a period of minimum 4 days. Once after curing the plugging point of **Water Guard Crysta Coat 101** becomes dry. It should be coated over with **Water Guard 491** so that there is

proper bonding between the pipe and the crystalline plugging material. The same treatment can also be repeated from the exterior side of the overhead tank.

**STEP 3:** Plugging internal pipe points. (If needed).

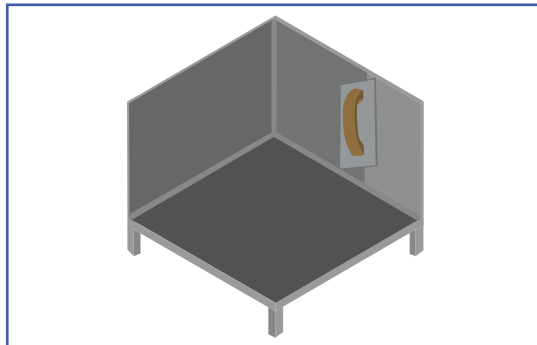
## Step 4: Internal Plastering (if needed)

As mentioned previously, if there are hollow sounds within the plaster of the overhead tank, the entire area should be replastered. Replastering works can be done either with the use of **Patch 365 Plus** (Please refer to product datasheet for further information) or by adding **Ressi SBR 5850** and **Silmix** in the cement and sand mix.

Using **Silmix & Ressi SBR 5850** as mortar admixtures ensures that there are no cracks in the plaster it is water repellent. It is recommended to add 1 Liter of **Silmix** along with 1 Ltr of **Ressi SBR 5850** with every bag of cement used for the plastering of internal & external areas of the overhead tank.

It is to be ensured that the internal plaster of the overhead tank should be finished slightly rough, exposing some grains using a foam (Foam finish plaster). This will provide a good key for the subsequent coating of **Water Guard Crysta Coat 101** & **Water Guard 491**.

**STEP 4:** Internal Plastering (If needed).

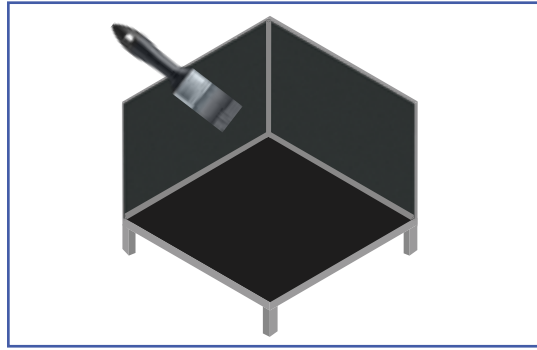
## Step 5: Application of Water Guard 491

Once internal plastering has been done and cured properly, it is recommended to apply 2 coats of **Water Guard 491** over the surface of the plaster. A minimum of 2 coats of **Water Guard 491** are recommended. Both the coats should be applied in an opposite right-angled direction (if the first coat is applied in a top to bottom direction, the second coat is to be applied in a left to right direction). It is to be ensured that all the coating of the materials is to be done properly and a proper film of the material is created over the plastered surface.

**STEP 5:** Application of **Water Guard 491**.

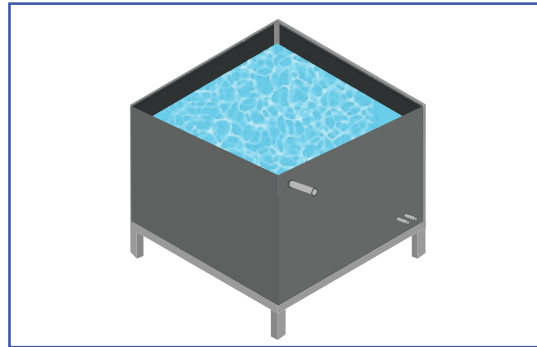
## Step 6: Flood Test and usage of tank

Once the coating of **Water Guard 491** has been completed, the overhead tank can be filled with water. In case there are still some leak points within the tank, they should be rectified accordingly. If all the diagnosis and application works have been conducted properly, there should not be any leakages in the overhead tank.

**STEP 6:** Flood Test.

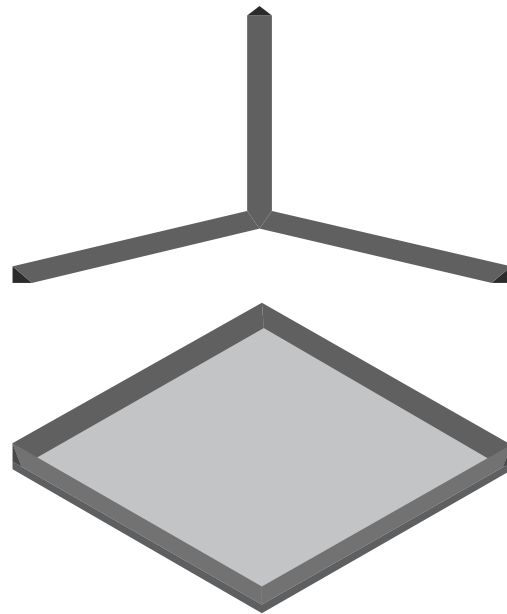
## What is a Chamfer?

Is a transitional edge between two faces of an object. Sometimes defined as a form of bevel, it is often created at a 45° angle between two adjoining right-angled faces. (Wikipedia).

In waterproofing systems, making a **chamfer** is of great significance. Water normally gets stuck in areas which have sharp corners of 90° & on several occasions the leakage of water occurs from this the sharp angle of the water retaining bodies or areas where significant waterproofing is required. To minimize the effect of this, a **chamfer** is usually created to make sure that there are no sharp angles in the structure to minimize the effect of water coming in & out of the structure.
