SOLUTION FOR PLASTER DEBONDING FOR OLD CONSTRUCTION

(RENOVATION)

Solution for Plaster Debonding for old construction (Renovation)

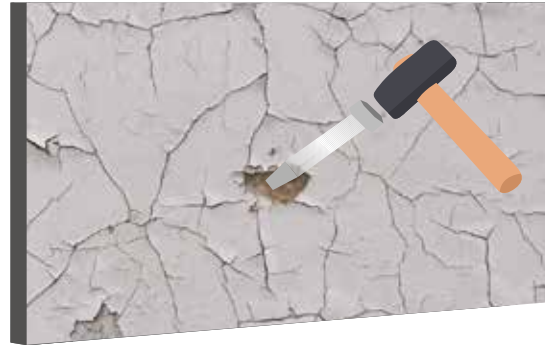
A. Patch 365 Plus

Using Patch 365 Plus: If there is a movement within the structure or a plaster with added flexibility & water resistance capabilities is required, **Patch 365 Plus** is an ideal product for that.

Patch 365 Plus is a two-component dry premix repairing mortar useful for the repairing of old deformed plaster works, damaged floor screed with potholes and concrete where surface honeycombing has occurred. Please refer to the product technical datasheet for further information.

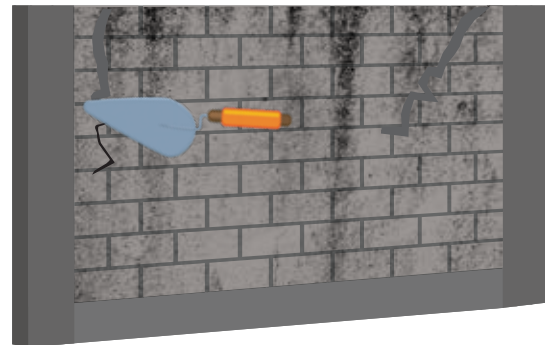
B. Adding Ressi SBR 5850 and Silmix in the Plaster Mix.

Adding **Ressi SBR 5850** and **Silmix** in the Plaster Mix: A plaster comprising of a good ratio can also be applied over the wall area. It is recommended to add **Ressi SBR 5850 & Silmix** into the plaster mix. The recommended dosage of **Ressi SBR 5850 & Silmix** is 1 Ltr each to be added with the mix of every 50 KG bag of cement. Once the plaster has been applied and cured properly. Subsequent treatment can be done over the wall.
